## ASSESSMENT AND SURVEILLANCE OF EROSION RISK IN UNLINED SPILLWAYS

SE Pells<sup>1</sup>

### ABSTRACT

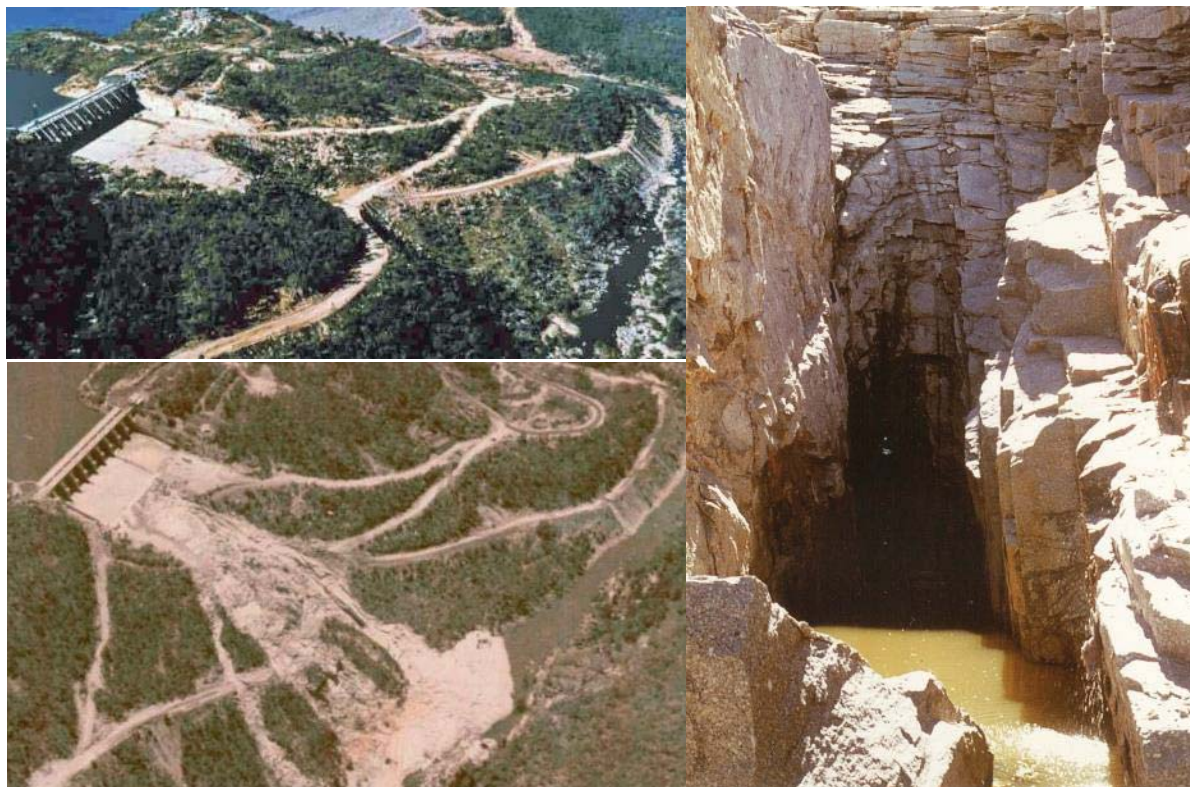
The spillway design at Copeton Dam, in New South Wales, Australia, comprises a (gated) ogee crest, which discharges over an initial lined section before plunging over the natural hillside toward the original river channel (Figure 2). During construction, a relatively small spill event (peak discharge of  $200 \text{ m}^3\text{s}^{-1}$ ) occurred. The flow quickly removed the existing roadway, loose debris and natural surficial material from the spillway (e.g. Region D in Figure 1). Substantial erosion of the underlying granitic bedrock then followed, creating a channel and plunge pool of 20 metres depth. The extent of erosion was unexpected by designers. Subsequent investigations on the now-exposed rock mass have explained the apparently high erodibility of the rock mass in terms of: very high residual stresses (Woodward, 1981); extensive sheet jointing parallel to the slope, providing a sliding mechanism (Fell,

et al 2015), and; the presence of a transpressional fault adjacent to the natural gully (Pells and Pells, 2015). Analysis presented in Pells (2015) demonstrated the significance of the lineal fault in amplification of hydraulic loading. The significance of this fault was not perceived during design and construction, and during subsequent spills, extensive further erosion of this fault has occurred.

**Figure 2. Copeton dam spillway. Top left: prior to spill. Bottom left: subsequent to the first spill event. Right: deep channelisation caused by erosion**

For example, at Copeton dam, following the major erosion from a relatively small flood event, a series of controlled test spills were undertaken to test the erodibility of the unlined spillway, followed by detailed inspection and topographic survey. These tests indicated ongoing rapid erosion. Based on these tests, the spillway was modified to create two separate spillways – a service spillway over a region proven to be more erosion resistant, and a secondary spillway, to be used with greater caution.

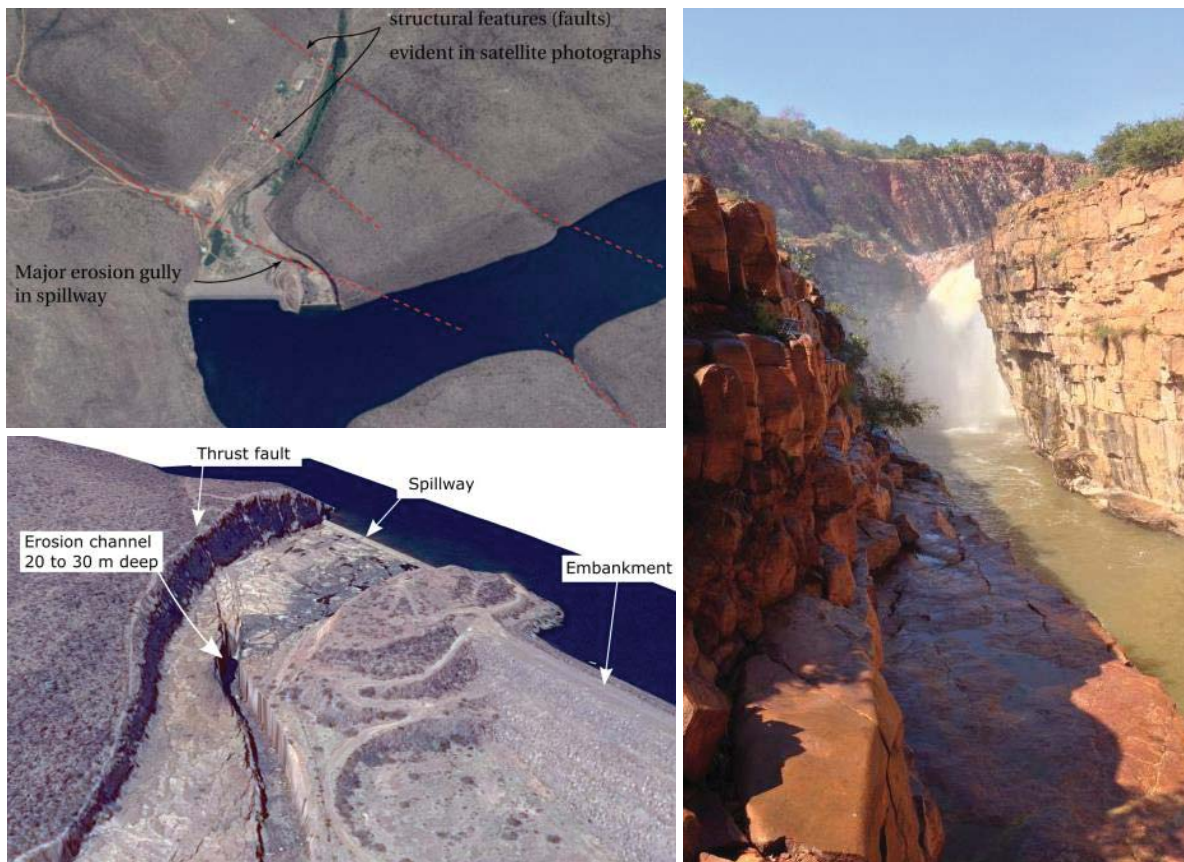
At Mokolo dam, in Limpopo Province of South Africa, lineal faults are readily perceived from aerial photographs (Figure 3), but the significance of a thrust fault passing through the excavated section of the unlined spillway (e.g. Region B in Figure 1) was not appreciated during design. Erosion along the fault line, approximately 2 to 3 m depth, developed after the initial spill event in 1981 (peak discharge of  $82 \text{ m}^3 \cdot \text{s}^{-1}$ , Pells, 2015). Subsequent spill events have enlarged erosion along this feature, with erosion 20 to 30 m depth observed after the flood of record (peak discharge of  $920 \text{ m}^3 \cdot \text{s}^{-1}$ , Pells, 2015) in May 2014.

**Figure 3. Mokolo dam spillway. Top left: aerial photo showing regional faults. Bottom left: perspective of current erosion slot. Right: deep erosion slot.**

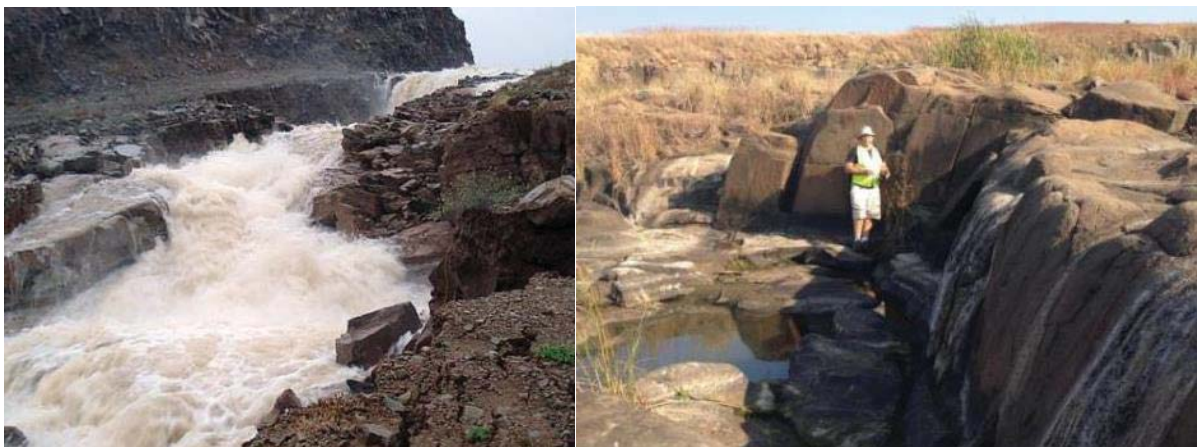
Over-blasting during construction of the spillway at Osplaas dam, in Western Cape, South Africa, was a recognised problem, and necessitated lowering of the spillway channel by removal of disturbed material, and construction of a weir to achieve the design spillway sill height (Shelley, 2013). Notwithstanding this, during the first spill, significant erosion channels formed (see Figure 4) within the blast-disturbed formations (i.e. Region B in Figure 1) which cut into the underlying formations.

At Klipfontein dam, in kwaZulu / Natal in South Africa, the transition of the spillway from the excavated section onto natural materials (i.e. Region C and D in Figure 1) was marked by an increase in gradient. The upper weathered dolerite 'core-stones' were readily removed by first spillway discharges (Figure 4). Over subsequent floods, the extent of erosion found to be limited to the weathered zone, with intact formations underneath adequately resisting erosion.

**Figure 4. Erosion of blast-damaged rock at Osplaas dam (left) and weathered dolerite at Klipfontein dam (right)**

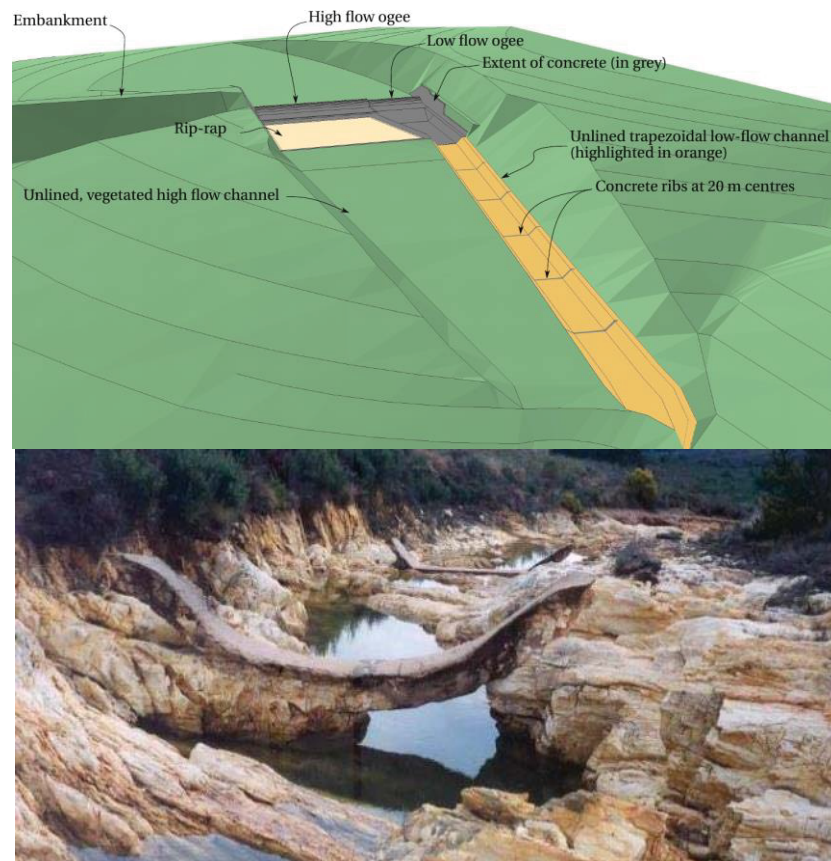
Soft-rock material forming the unlined spillway at Haarlem dam, in the Western Cape of South Africa, suffered major, progressive erosion through the excavated region (i.e. Regions A to C in Figure 1), initiating from the first spill events. In this case, there were no structural features revealed after the first spill which were the cause of erosion, it was primarily that the natural material was proved to be more erodible than perceived during design (Figure 5).

**Figure 5. Highly erodible soft-rock at Haarlem dam**
